# Annual Compliance Report - Year 1 (EPBC 2018/8166)

Harvest Estate, Byron Bay (EPBC 2018/8166)

Prepared for Villa World Byron Pty Ltd

By Planit Consulting Pty Ltd

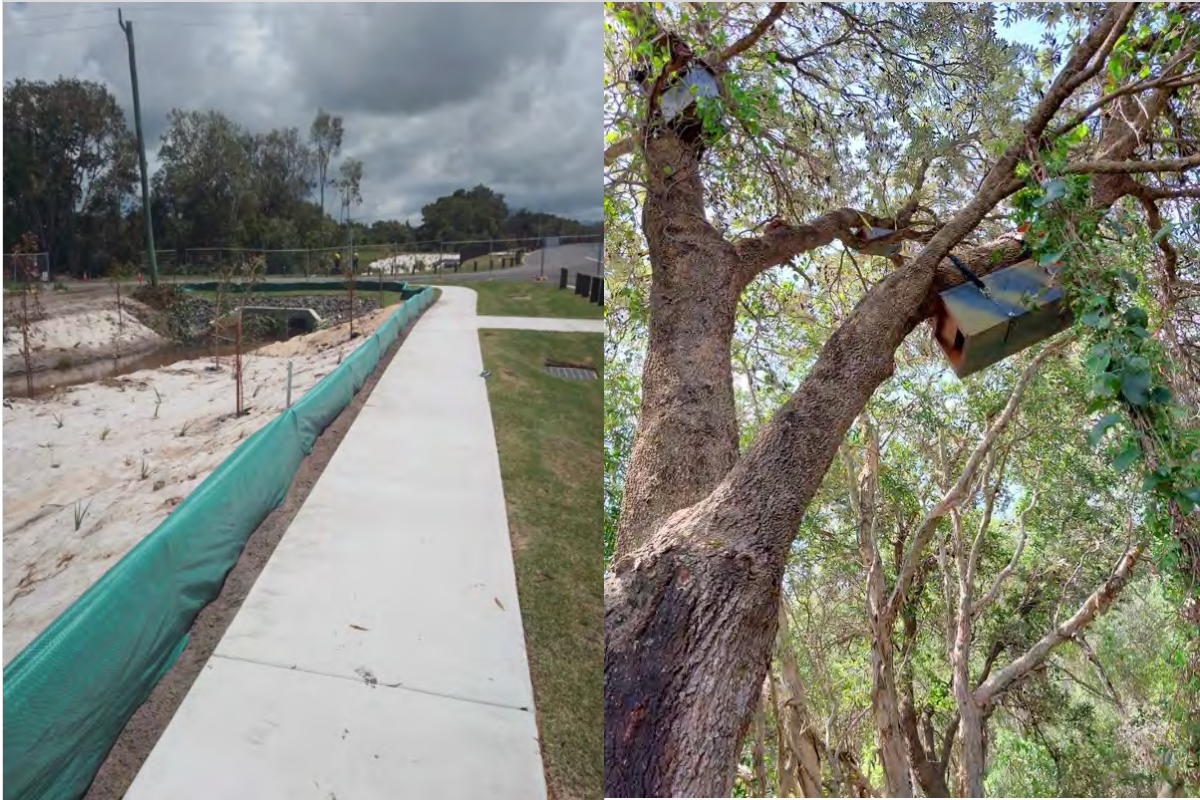
*Frog Fencing Installed Between Frog Habitat Zones*

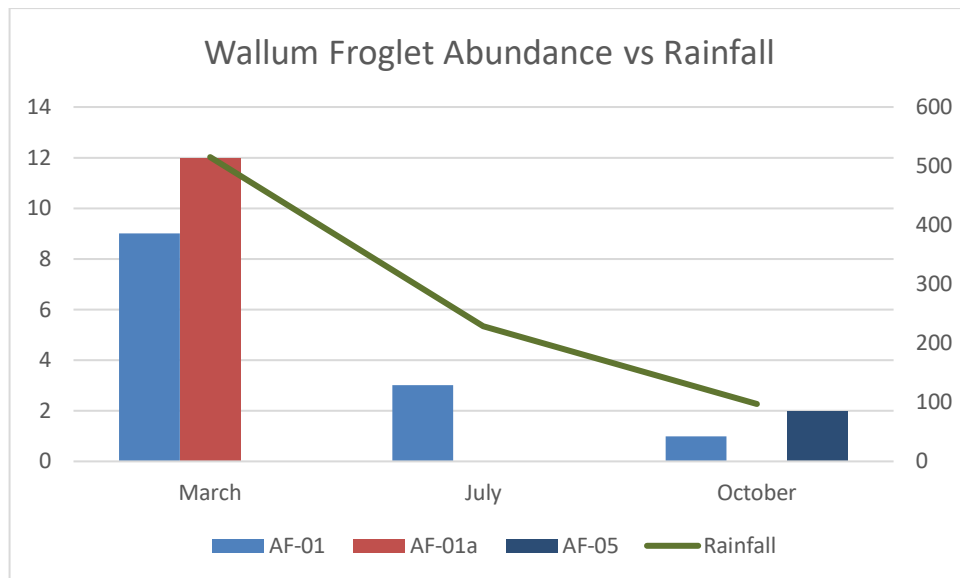
Rainfall during the July-October period also declined markedly, with just two large rainfall events occurring since June (>20mm/day) and monthly rainfall totals 65% below the historic average. Monthly rainfall data is provided in Appendix B.

Figure 4.1 Graph of rainfall with records of Wallum Froglet

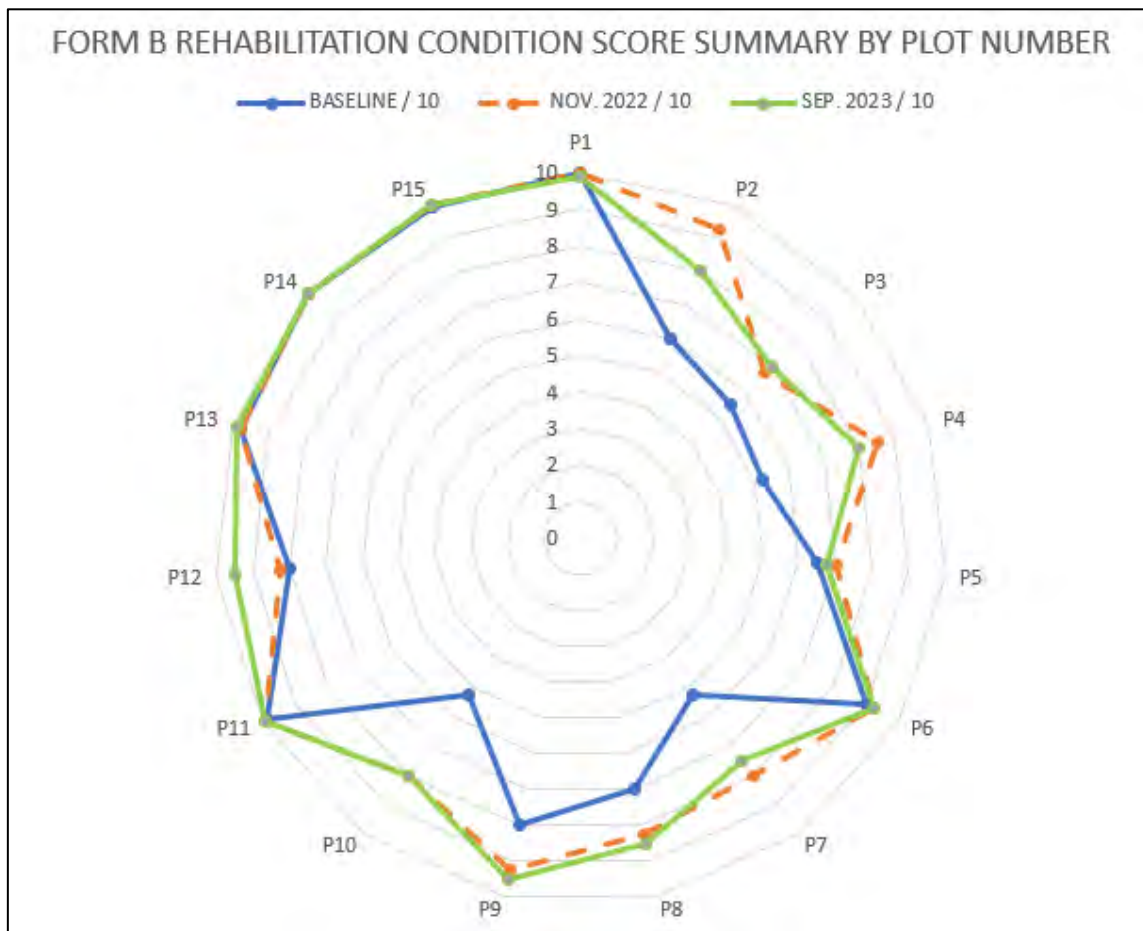
Form B Overall Condition Score Summary			
Plot No.	Baseline	Nov. 22	Sep. 23
P8	70	82.5	85
P9	80	92.5	95
P10	52.5	80	80
P11	99	99.5	99.5
P12	80	82.5	95
P13	97.5	97.5	99
P14	100	100	100
P15	99	100	100

Figure 6: Condition Score Baseline Comparison

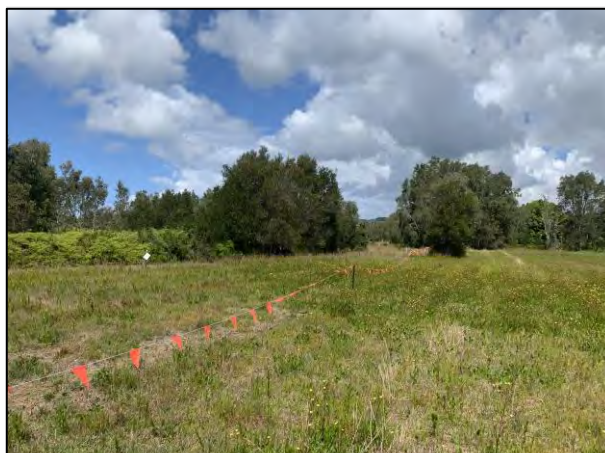
PREVIOUSLY SLASHED AREAS OF REHABILITATION ZONE 1 (SEP 2023)

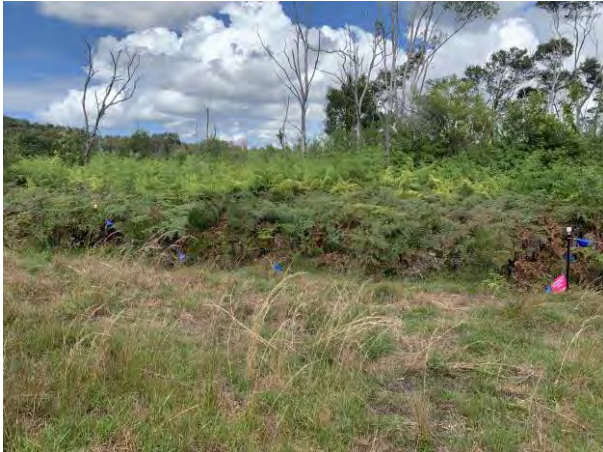
INCIDENCE OF NON-COMPLIANCE TO BE RECTIFIED: FENCNG REQUIRING REPAIRS

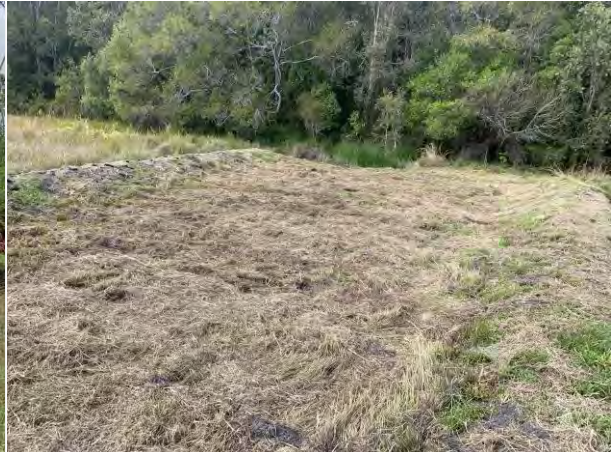
INCIDENCE OF NON-COMPLIANCE TO BE RECTIFIED: FENCING REQUIRED AT THE INTERFACE OF REHAB ZONE AND DEVELOPMENT FOOTPRINT/SWALE

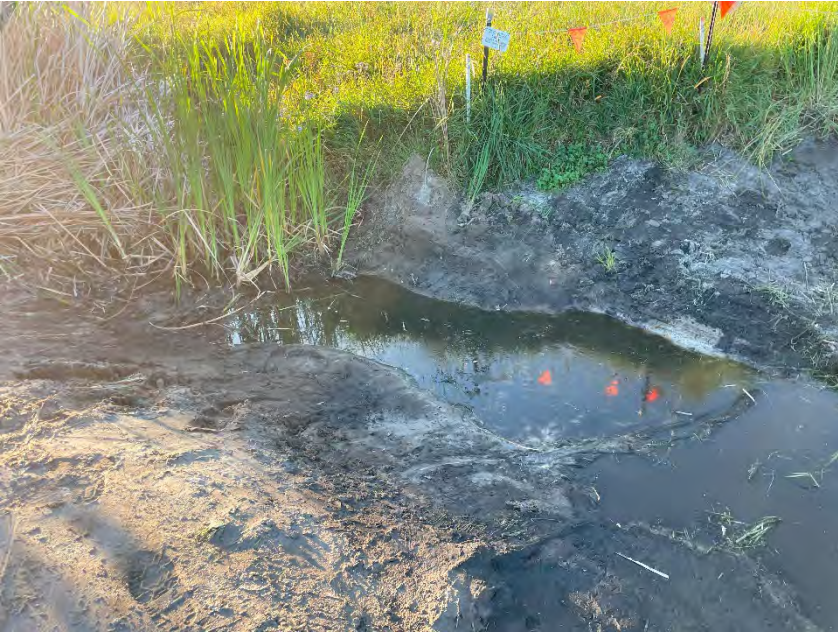
<b>Photo No.</b> 1	<b>Date</b> 21/08/2023

<b>Description</b> Monitoring location SW01. Evidence of earthworks within drainage line

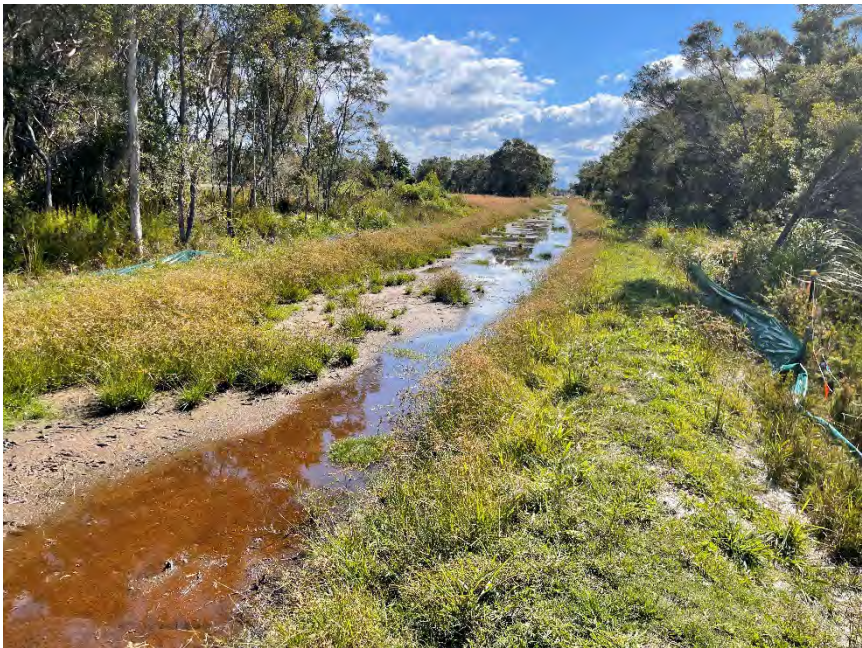
<b>Photo No.</b> 4	<b>Date</b> 21/08/2023

<b>Description</b> Surface water monitoring location SW04. Iron staining evident.

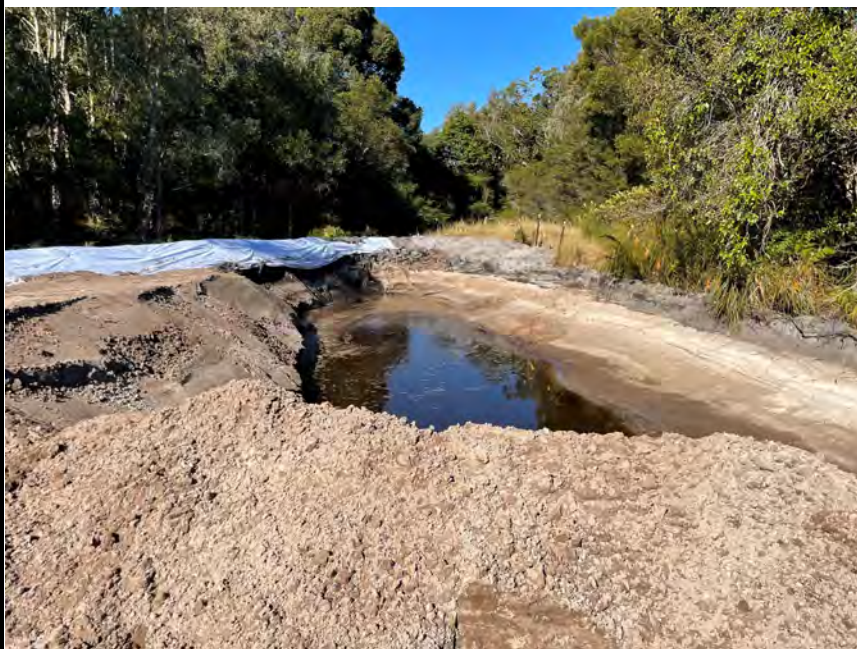
**Description**  
 Northern main drain rain re-alignment works commencing adjacent to monitoring location SW03. No site related works had occurred within the waterway at the time of monitoring.

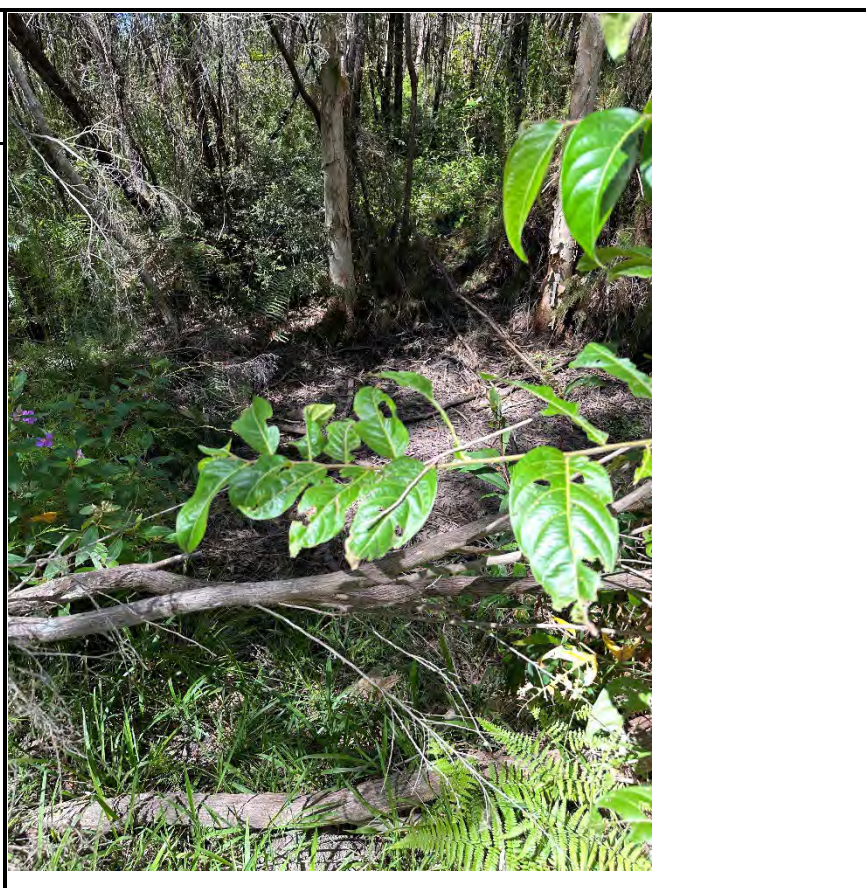
<b>Photo No.</b> 4	<b>Date</b> 14/11/2022
-----------------------	---------------------------

**Description**  
 Surface water monitoring location SW04. Location was dry.
